Notes from a Balcony Inspection

"Leaking through to the apartment below"

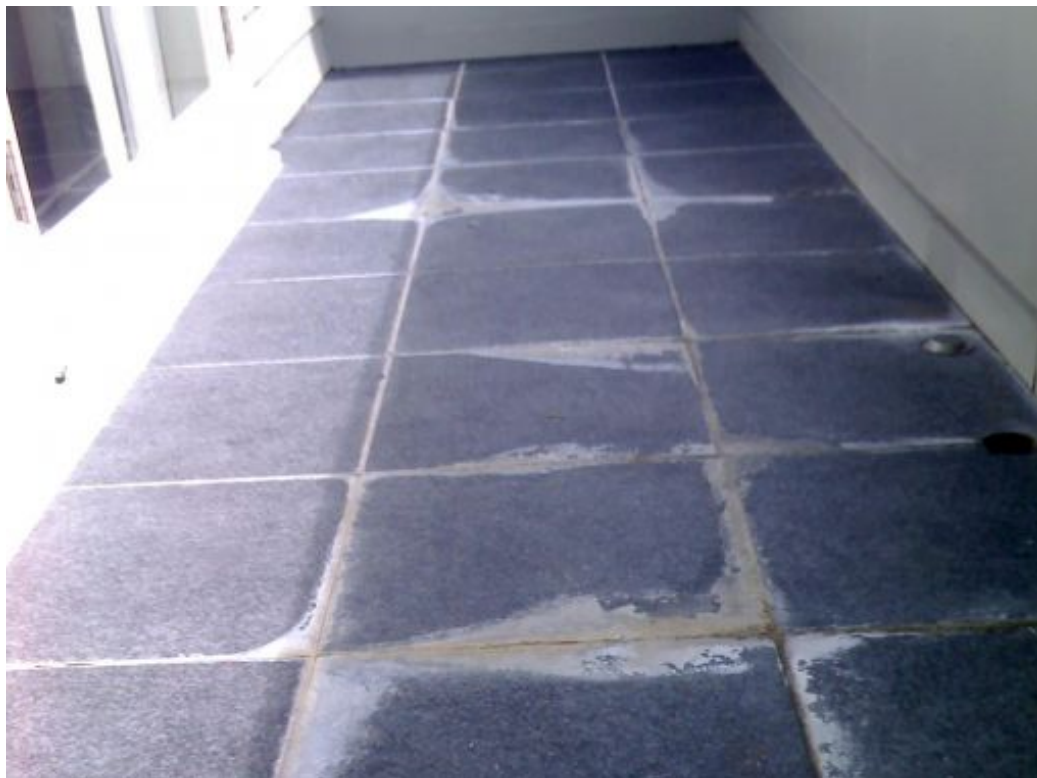
This "growth" causes the tiles to be forced upwards as they have no other way to go, especially if the tiles are laid too close to the perimeter walls as well. The upward movement can cause tearing (if installed) of the membrane below tiles or at least dislodging tiles. This can be seen particularly at the expansion joints where the tiles are lifting and tend to peak upward more than the general field of tiles.

The effervescence (whitish coloured calcification of salts and minerals) migrating up from the joints shows us the

sand and cement screed below tiles is holding water in the long term as the effervescence requires dormant water to form. (This is similar to stalagmites / stalactites in caves)

This particular balcony shows extreme signs of calcification at the west end on the outside edge and down the wall to the neighbour below. Noting this overall problem is evident in the neighbouring apartments as well.

It can be resolved by using the correct application with the right materials for the job.
