# Paragon Office Building Large Commercial Balcony

## Project Details

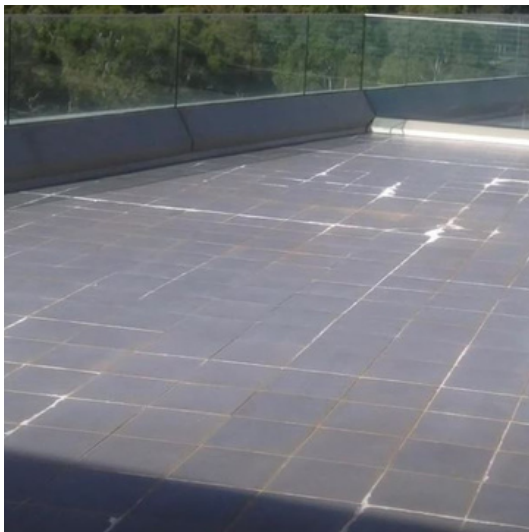
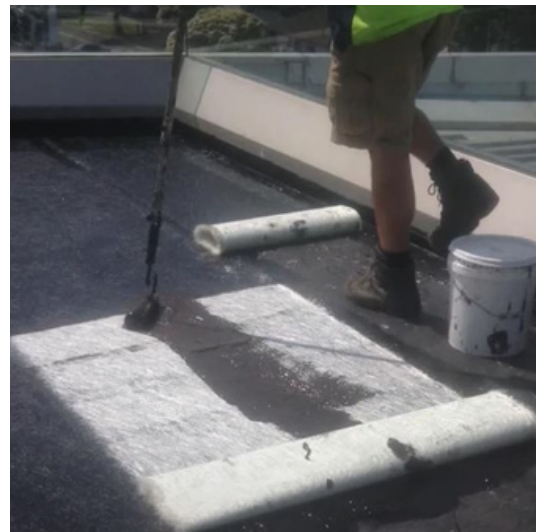
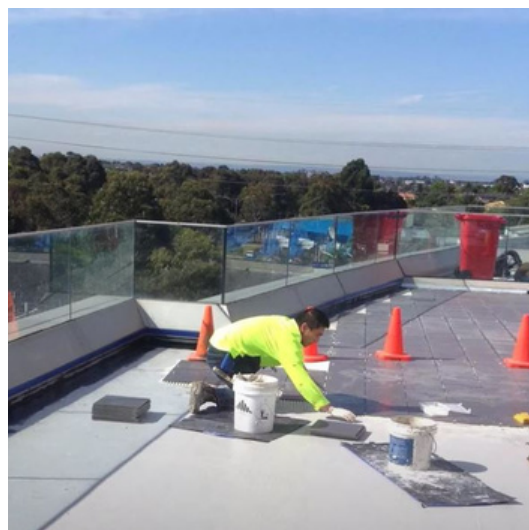
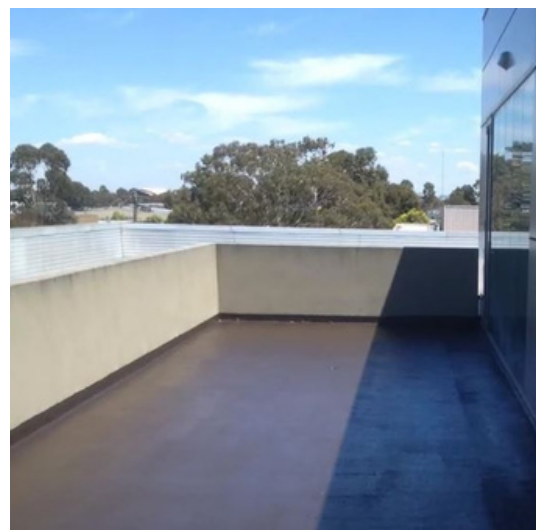
The waterproofing project involved a commercial office building with several tiled balconies that had leakage problems. Despite the building being only 8 years old, issues such as surface lifting and leaking were identified, originating from the improper installation of the original membrane and poor drainage design.

Multiple issues with water leaks were discovered, including invasive inspections showing problems with the membrane and screed.

The screed was generally in good order but required some repairs; it was retained as a secondary barrier.

The balcony had poor drainage with little slope, requiring the installation of new puddle flanges, droppers, and other plumbing works for proper water control.

A completely new membrane system was installed, along with necessary screeding and remedial plumbing work.

Specific detailing was done with polyethylene fabric and a liquid rubber waterproofing system, strengthened with fiberglass mesh for durability.

The waterproof membrane was over-coated with a Thermo Top Coat membrane, adding robustness, and the Findlay-Evans Team efficiently prepared the balcony for tiling.

The overall project addressed many points of water ingress, installed new expansion joints into the tile surface, and ensured the proper waterproofing of all balconies.
