If It Has a Balcony, It Will Leak

This article diving into the question “Why is my balcony leaking” has been supplied by Paul Evans, President – Australian Institute of Waterproofing (AIW).

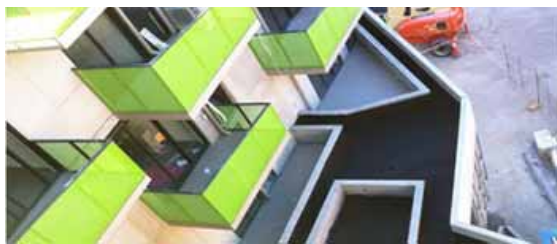
All too often, penetration of water through the top balcony surface and exposed edges of both reinforced concrete balconies and timber framed balconies, leads to deterioration of the balcony structure and significant defects occur, such as concrete spalling.

Accumulation of **calcium crystals** and salts, known as “Efflorescence” occurs on balcony surfaces only in the presence of water.

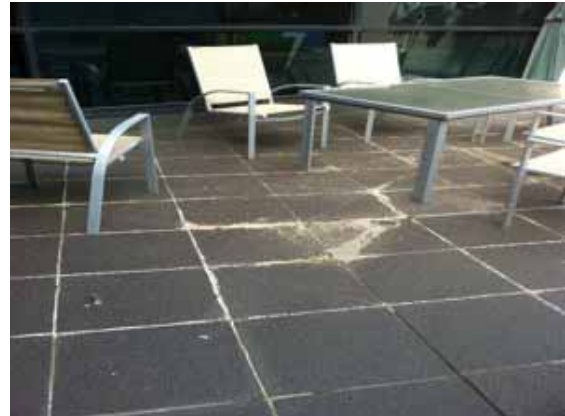
Poorly detailed balcony surface transitions, interfaces and penetrations can lead to water ingress into occupied spaces below which in turn may lead to serious structural damage.
