Steel Mains Large Steel Factory

Project Details

The project presents a case study of a large factory complex in Somerton, used for fabricating steel pipes, where several large vats were causing water leaks and high temperatures, leading to minor explosions. Findlay-Evans Waterproofing was called to solve the problem, and the images show details on their approach and solution.

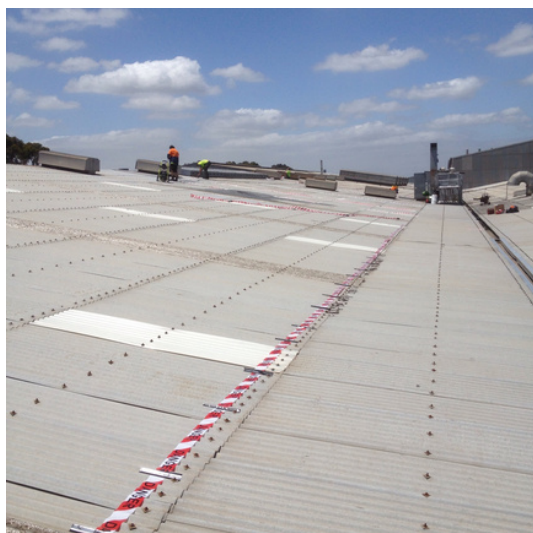
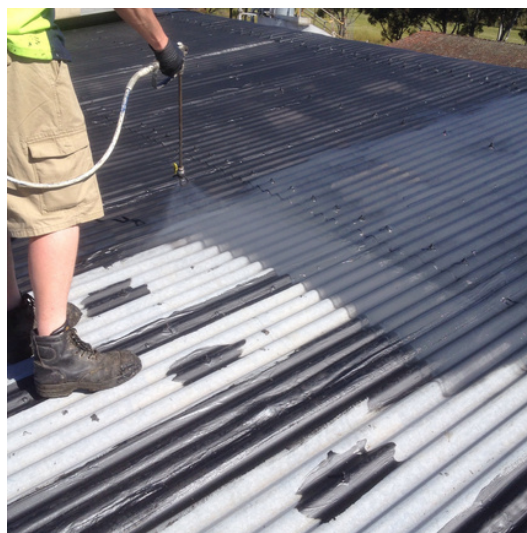
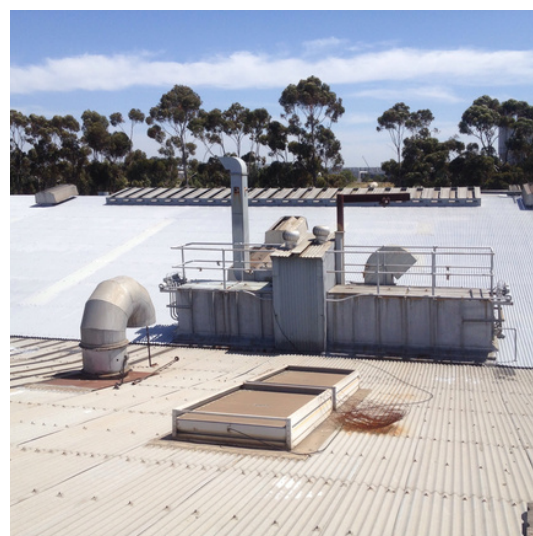
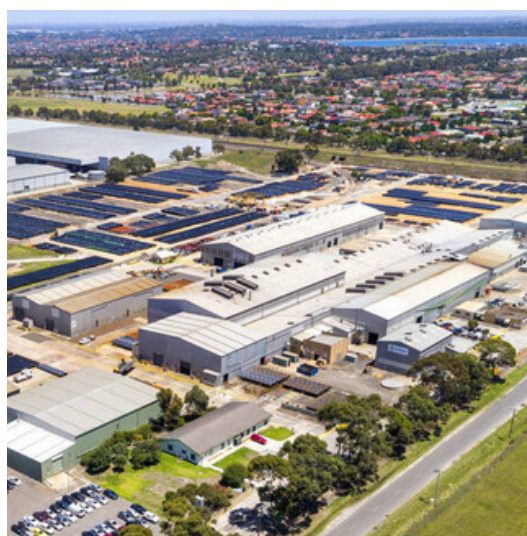
Found the roof was leaking throughout.

Decided to spot fix various areas and overcoat the entire section.

Cleaned with power washing and detailed by hand.

Applied polyethylene fabric and liquid rubber as a base.

Added an etch coat primer and a thermal top coat.

Thermal top coat dropped temperature inside the building.
Solution appreciated by workers during the hot summer.
