Vibe Hotel Balcony Restoration

Project Details

Paul Evans from Findlay-Evans Waterproofing discusses a case scenario involving a commercial balcony on a city hotel. The balcony, an extension made of timber, had severe deterioration due to the use of chipboard flooring and improper construction methods, leading to a dangerous situation.

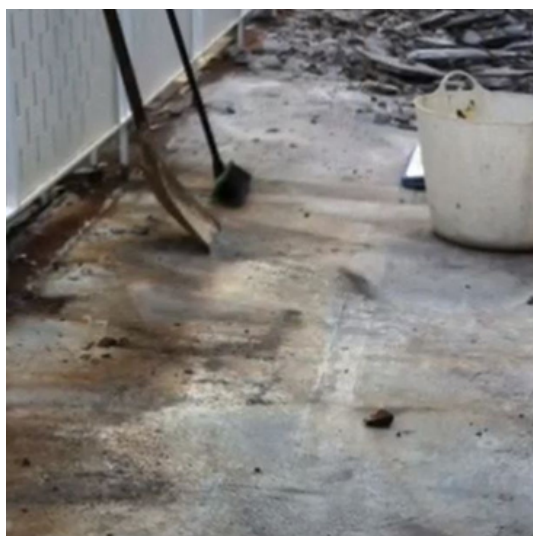
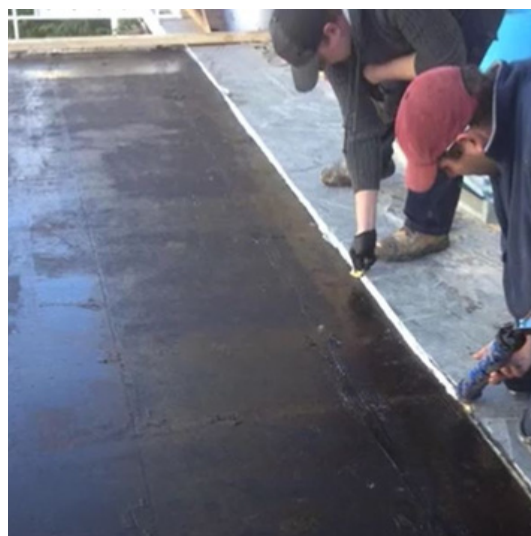
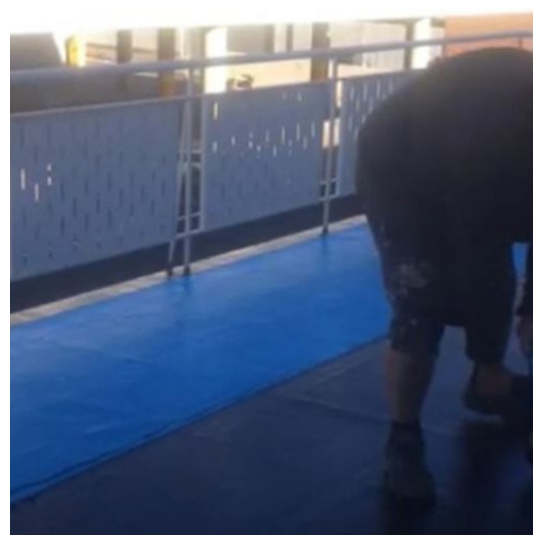
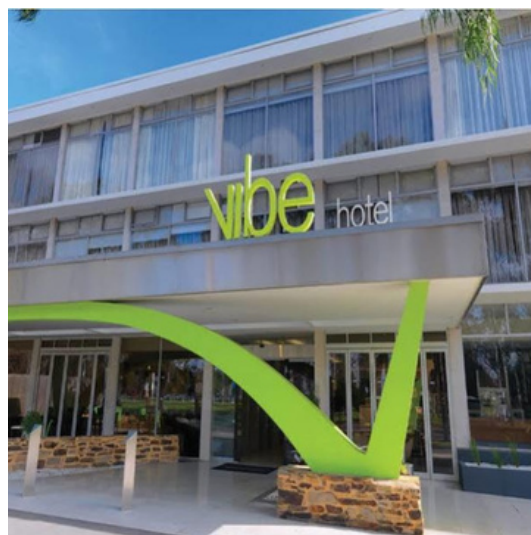
Leaking Balcony:

Extension made of timber on an existing concrete structure.

Chipboard flooring used over timber joist, leading to severe deterioration.

Tiled with crazy paving slay, contributing to the problem.

Joist and Flooring Replacement:

Replaced several joists and timber flooring with Scyon sheeting (compressed fibrous cement sheeting).

Waterproofing Process:

Detailed all joints, junctions, and penetration points.

Installed two new drain points connected to the stormwater system.

Applied a base coat and sealed everything.

Installed reinforcing fabric over the entire area for robustness.

Built falls into the subfloor to guide water flow.

Applied a four-coat waterproofing system.

Installed Arma-Blue protection sheet.

Added grass over the protection sheet to isolate it from abrasion.
