Portsea Apartments

Remedial Waterproofing on a Large Balcony

Paul Evans from Findlay-Evans Waterproofing shares a story about restoring a leaking balcony in a prominent landmark accommodation in Portsea. The restoration involved stripping the existing pavers, re-screeding, and applying a Liquid Rubber membrane, all while battling weather challenges and complex scaffolding setup.

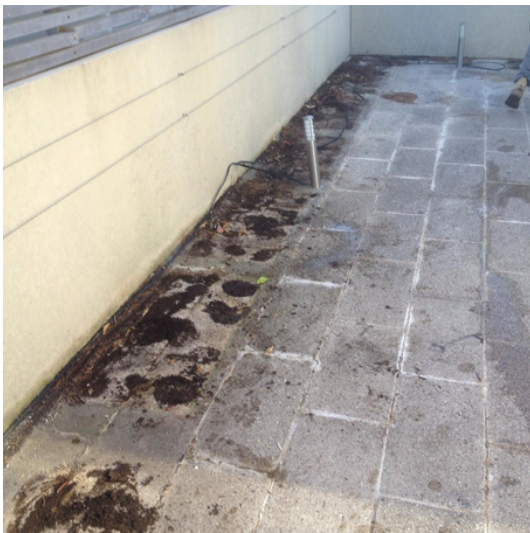
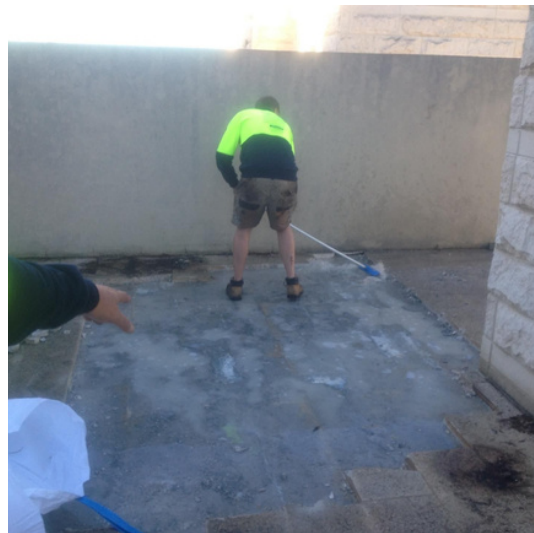
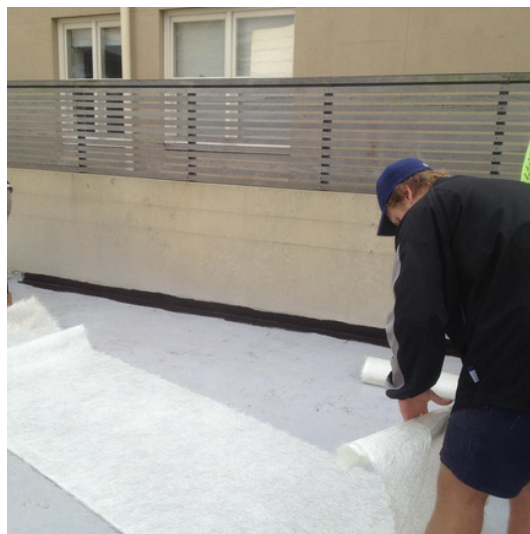
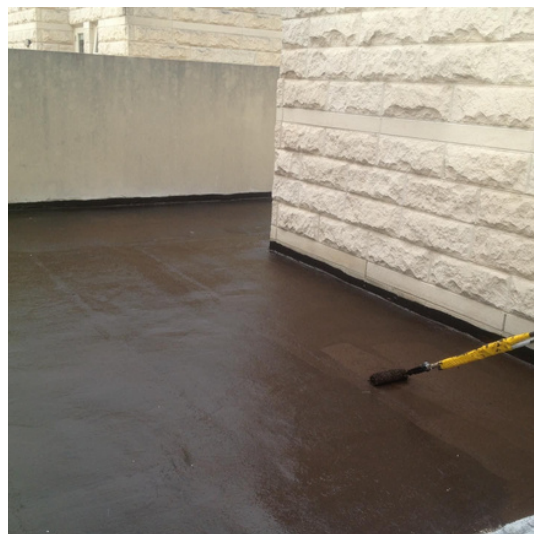
Removed existing pavers to reach the original membrane.

Stripped down to the original slab.

Applied Liquid Rubber membrane with a fiberglass interlayer for durability.

Applied a Mocha coat and installed brand new imported pavers.
