Sunshine Hospital Roof & Rooftop Plant Deck

Paul Evans discusses a waterproofing project at the Sunshine Hospital in Melbourne, focusing on the roof remediation of the plant deck section. The project involved the removal of an old butyl rubber roof that was leaking severely, followed by a detailed process of cleaning, coating, and sealing to ensure a watertight finish.

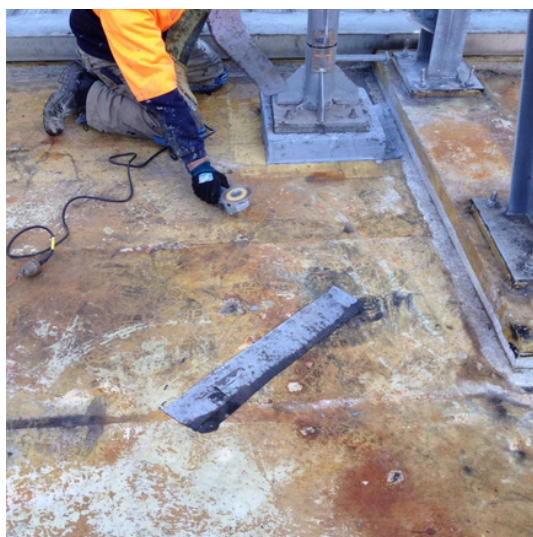
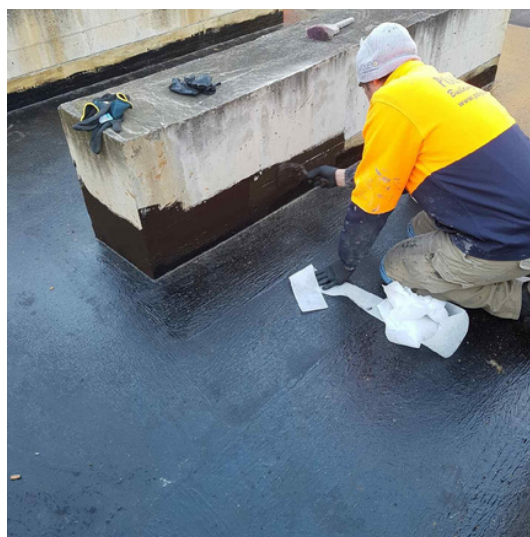
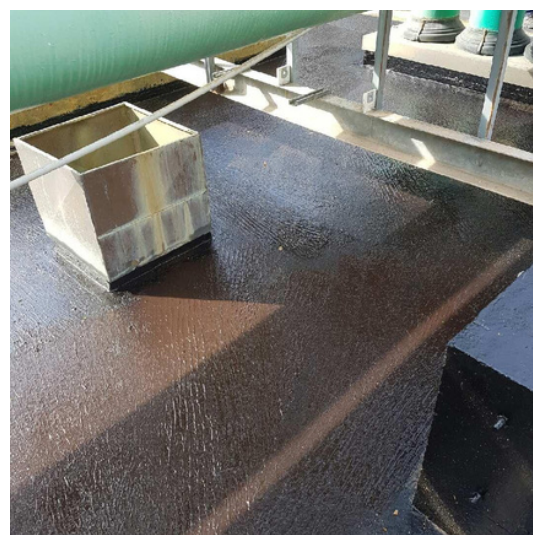
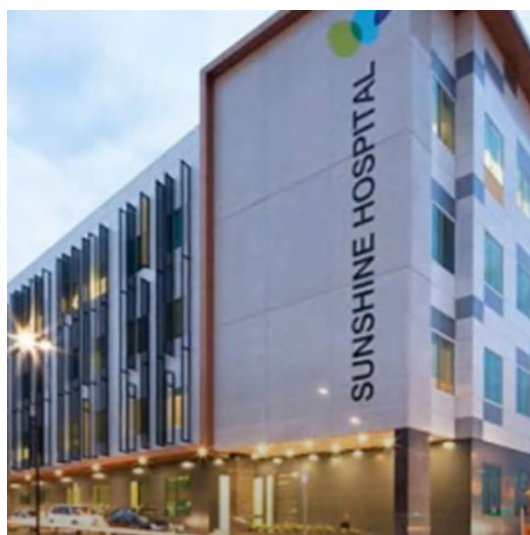
The old butyl rubber roof, applied 25-30 years ago, was peeling back and leaking severely, with concrete leaching from below.

The old rubber roof was stripped off, cleaned by power washing, and hand-removed glues.

Detailing Process: Hand detailing every penetration, masking everything off at the base, and applying a base coat of liquid rubber.

A three-coat system was applied in slow layers to build up a thick coating, including detailing all hubs and saturating the concrete to prevent water ingress.

Infrastructure Challenges: Working around low infrastructure, which was problematic for other types of coatings, but the ability to flood coat underneath low equipment provided a watertight seal.

Applying several coats of liquid rubber and fine-tuning the drainage section to make it fully watertight.
