Allied Mills

Remedial Waterproofing on Concrete Roof

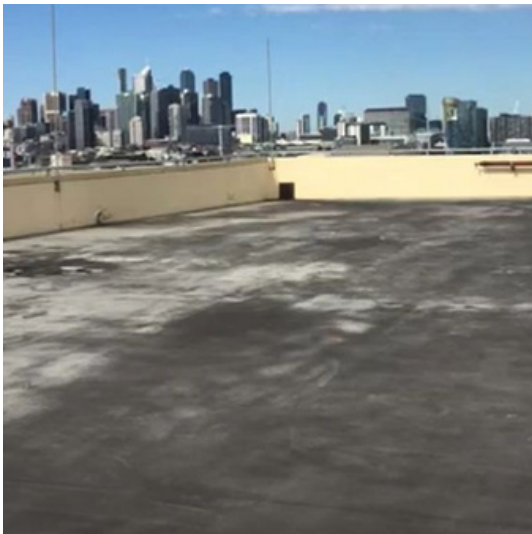
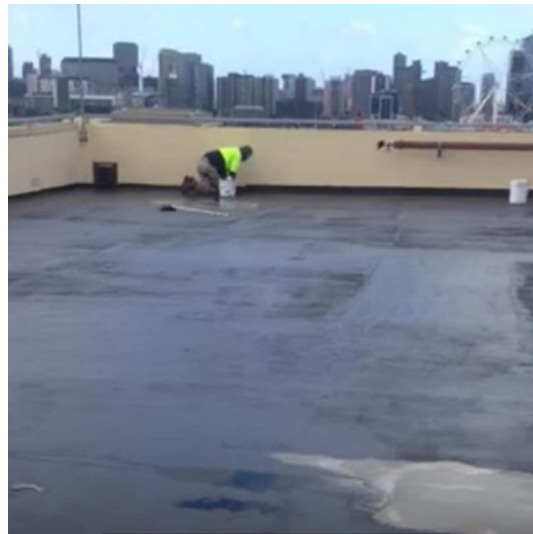
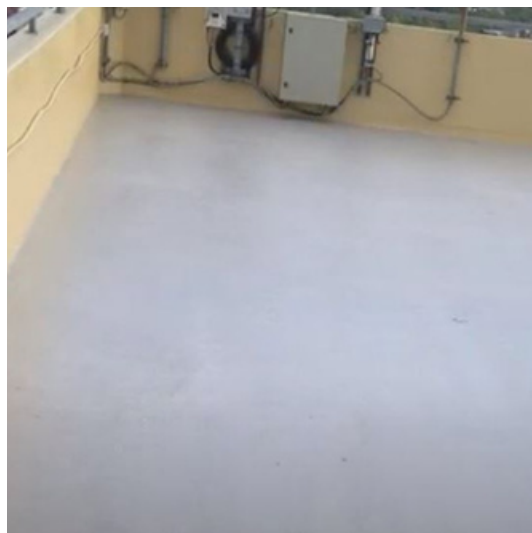
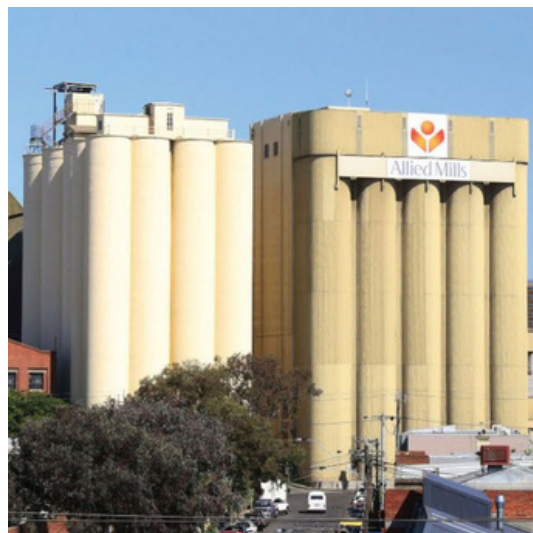
Concrete roof in good condition, but the existing polyurethane membrane was deteriorating.

Water ingress in the flour mill below was a significant problem.

Manual labor required to scrape off the old, rapidly deteriorating polyurethane membrane.

Cleaning of the concrete roof to ensure a good bonding surface.

Some areas were low and needed to be screeded with special flexible screed.

Application of Liquid Rubber membrane, chosen for its high flexibility.

Addition of a fiberglass interlayer to make the membrane more robust.

Overcoating with Thermo Top Coat to reduce the temperature below, aiding internal ventilation.
