Bega Cheese Waterproof Concrete

Project Details

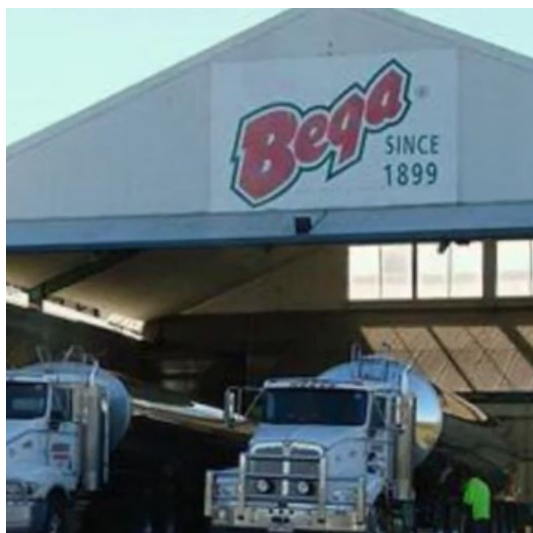
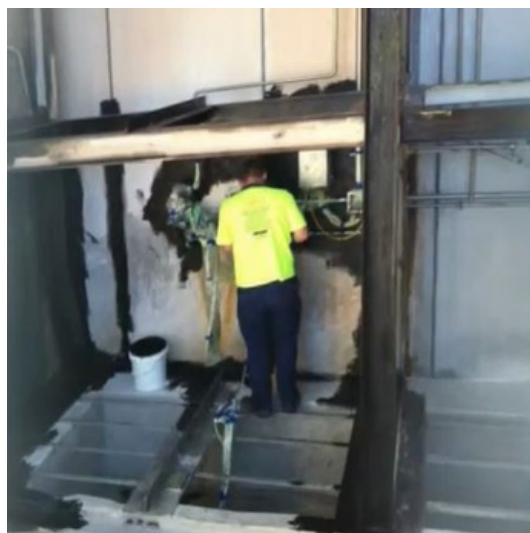
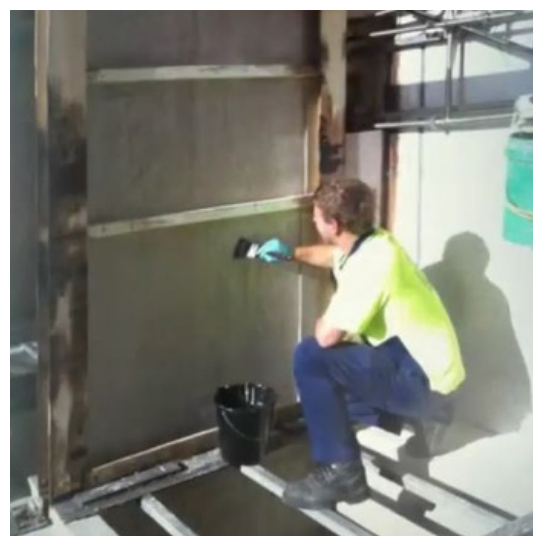
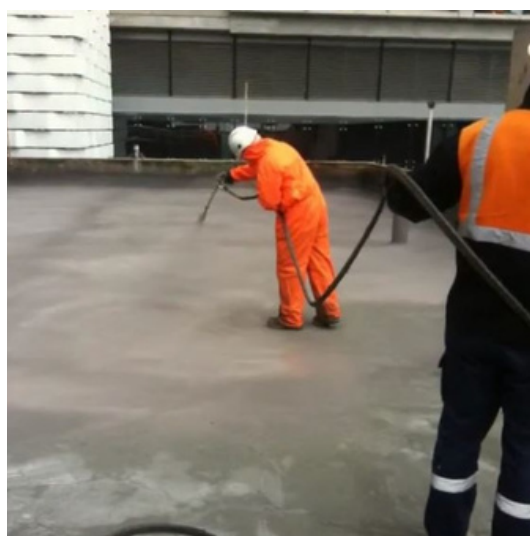
Chemical bond area used for storing chemical buns in cheese making.

Thorough cleaning of the concrete.

Allowing the concrete to dry.

Applying a prime product to seal the concrete and prevent chemicals from leaching out.

Masking off areas that didn't need to be sprayed.

Used a purpose-built spray rig in their liquid rubber mobile van.

Applied a 1.5mm thick coating to the entire confinement area.
