Substation J, Spencer St Melbourne CBD

Rooftop - Remedial Waterproofing

Project Details

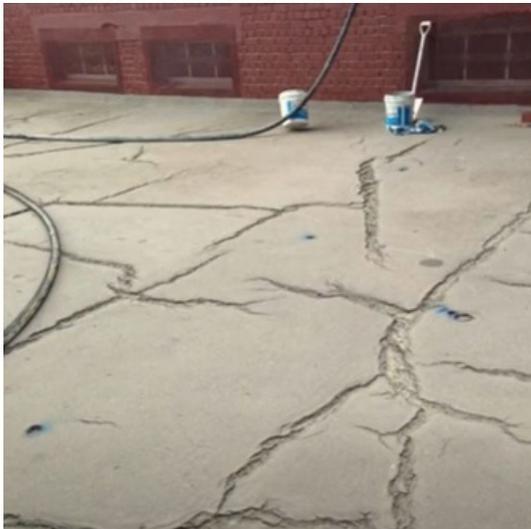
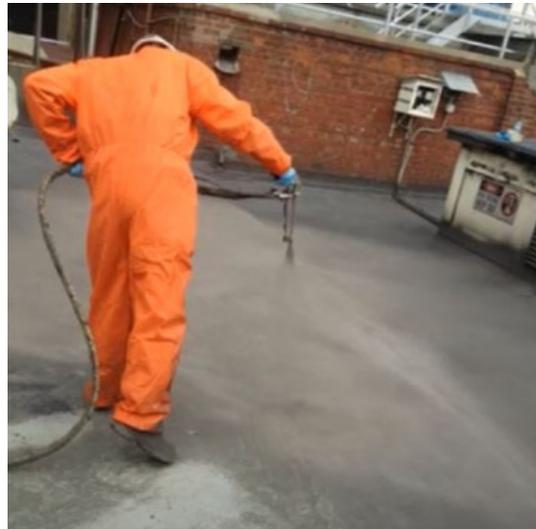
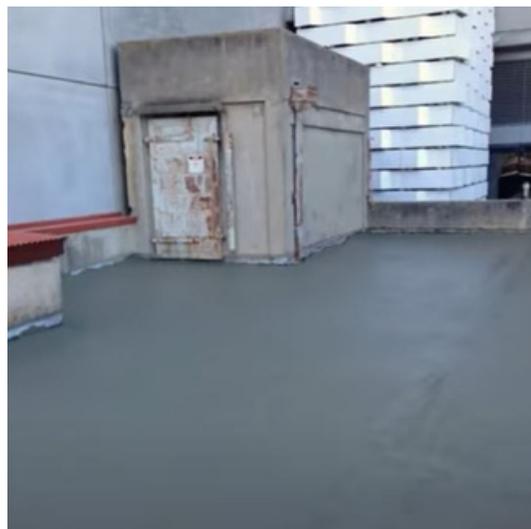
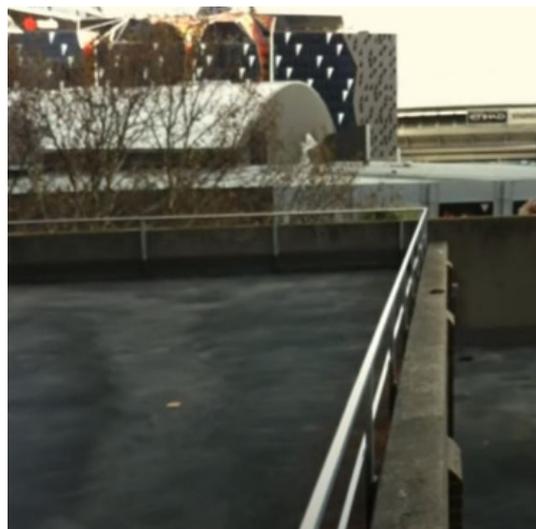
Badly deteriorated roof with leaks into the power station.

Identified five separate roof areas over the whole span of the building, each requiring individual treatment.

Pumped grout to the roof from the ground floor, filling all voids and cracks to create a new surface.

Sprayed Liquid Rubber membrane over the surface, building it up to a 1.5mm thickness, with specialized treatment in certain areas.

Used dark grey rubber to reflect heat and assisted builders with stairs joining into various levels.
