BALCONY & ROOF WATERPROOFING REPAIRS

Balcony Waterproofing Case Study.

A commercial balcony on a hotel in Melbourne.

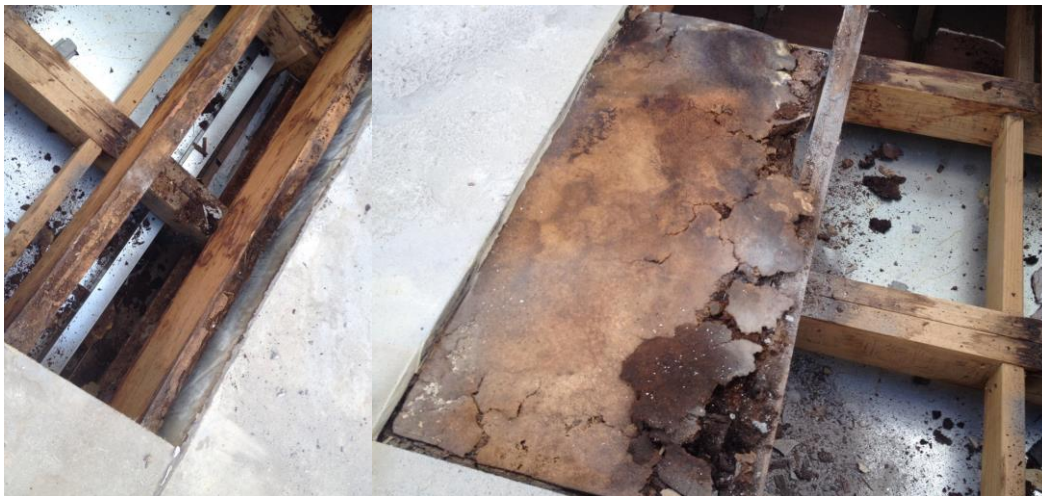
Replaced several timber joists and flooring. Flooring as tongue & groove.

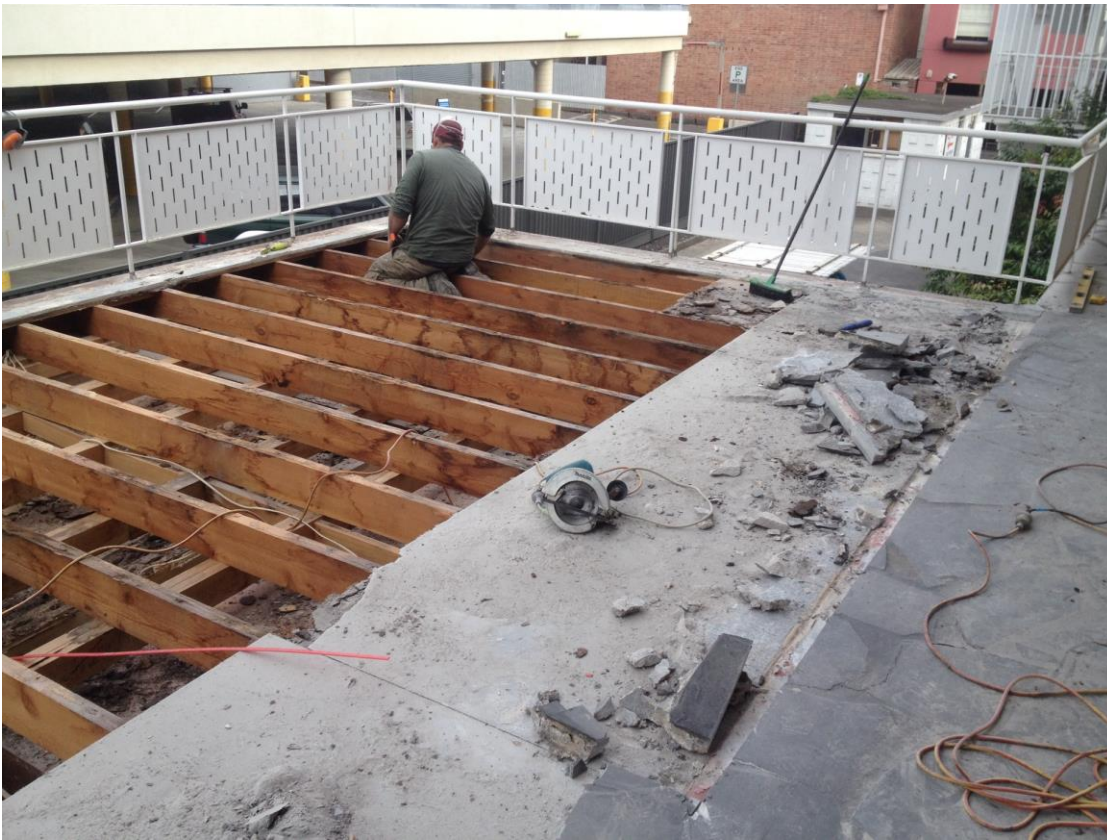
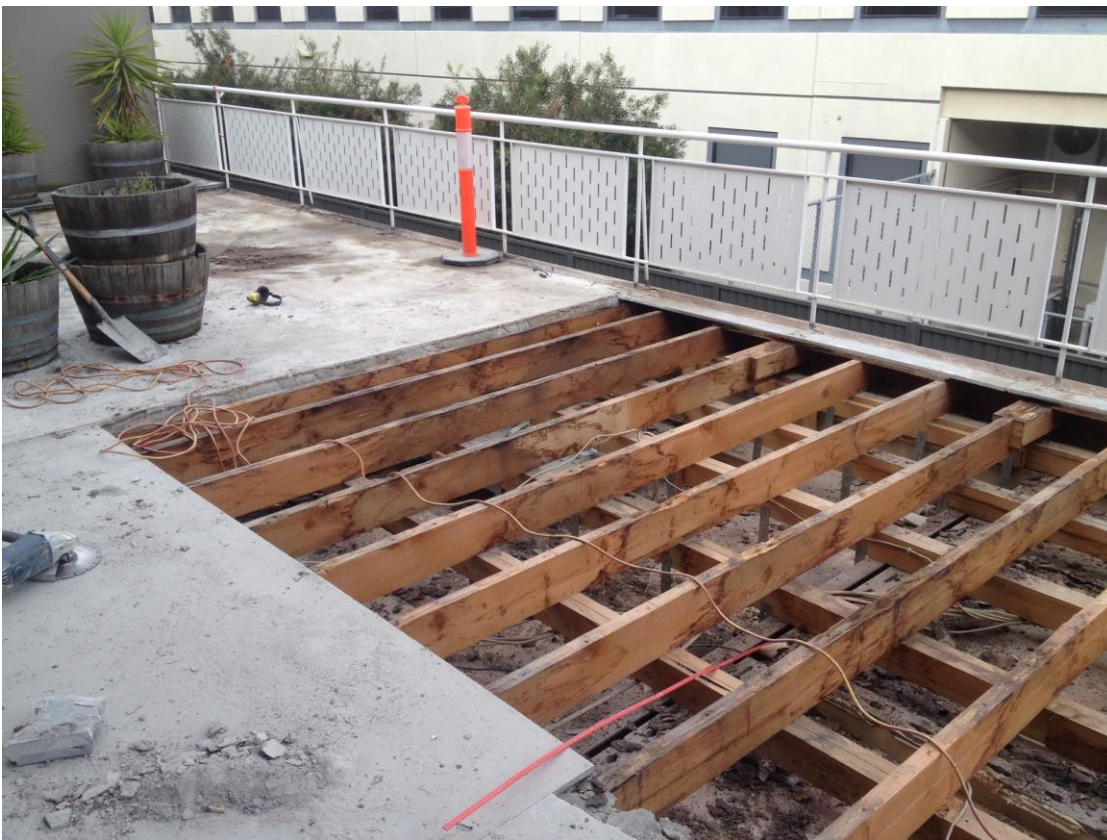
Once structural repairs were completed, then proceeded to install the waterproofing membrane.

Waterproofing preparation involved detailing to all the joints, junctions, penetration points, and draining.

To provide more drainage, Findlay-Evans installed two new draining points as well.

Our Team plumber connected the storm water system to alleviate the water shedding.

The Waterproofing Team spray applied a base coat of liquid applied waterproof membrane.

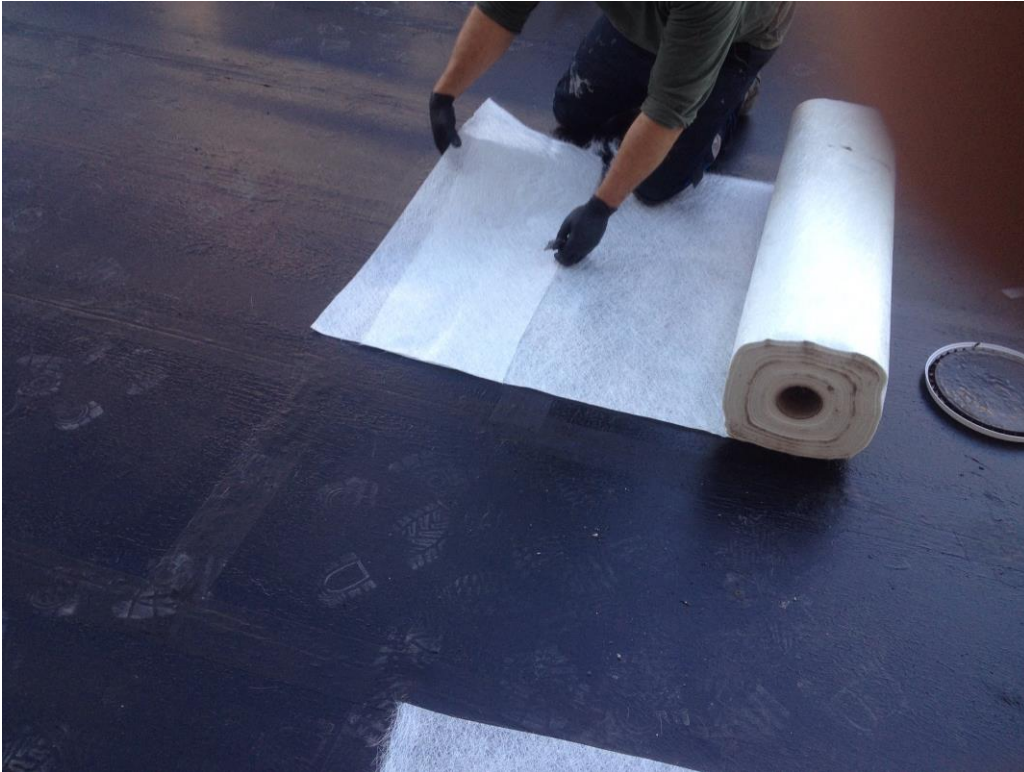
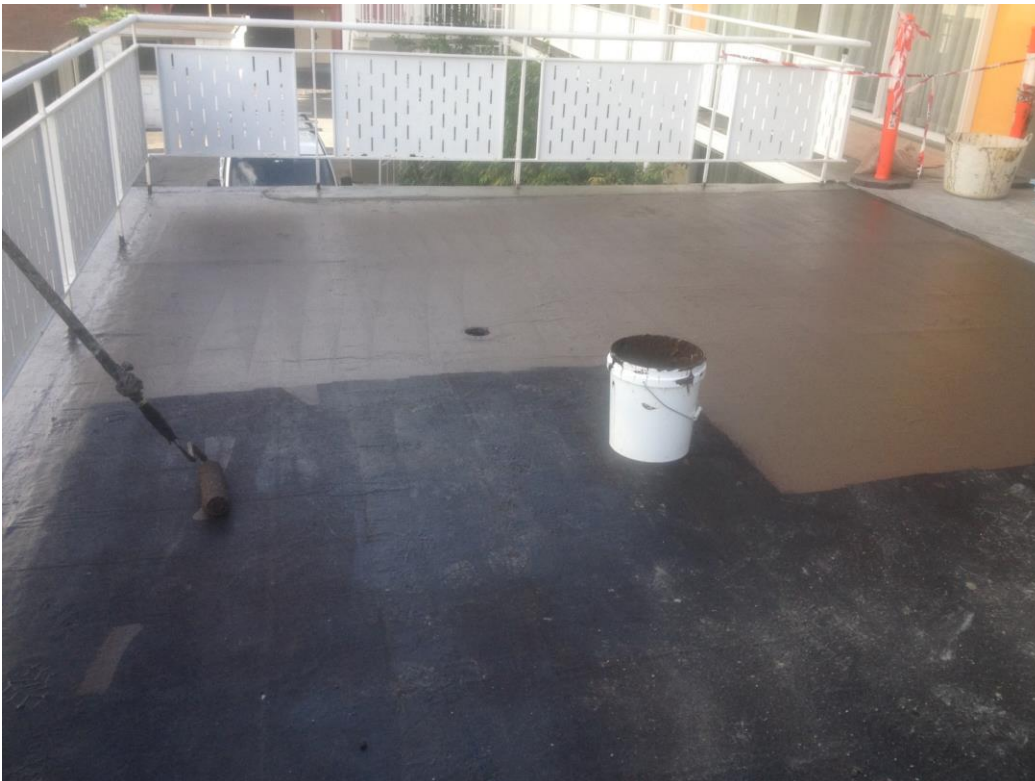
We then installed a reinforcing fabric over the entire area which strengthens up the membrane and makes it more robust.

Balcony falls were all built in to the subfloor.

As we installed adequate falls a screed was not required.

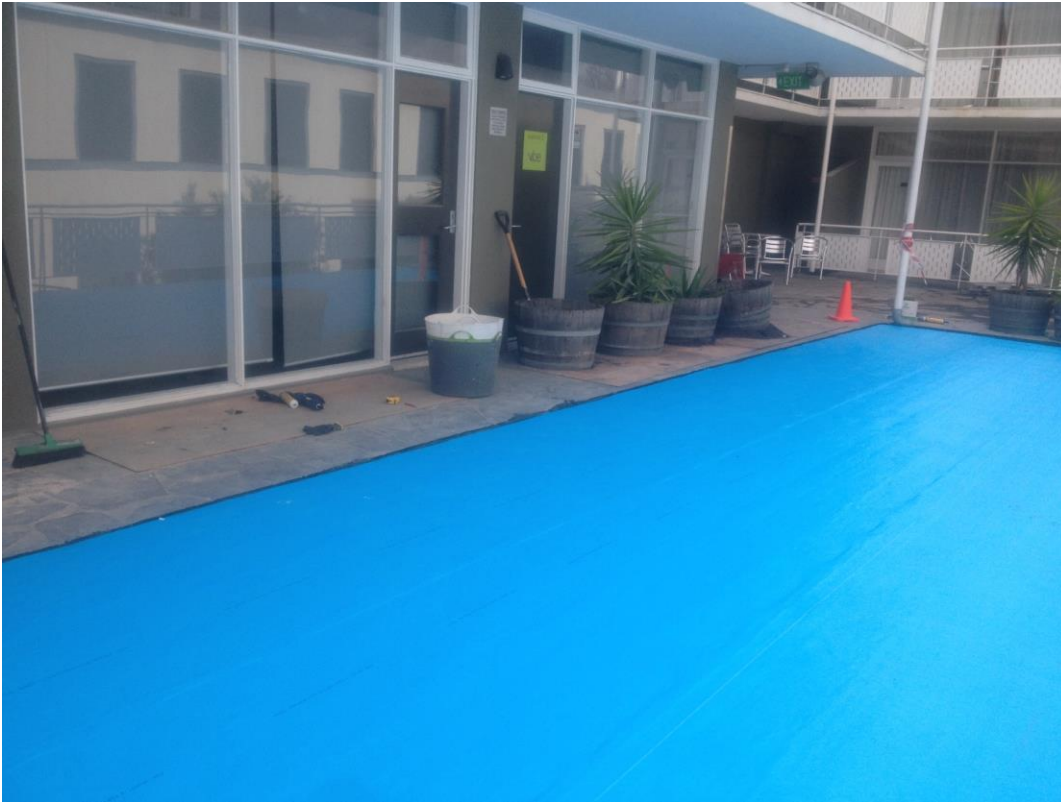
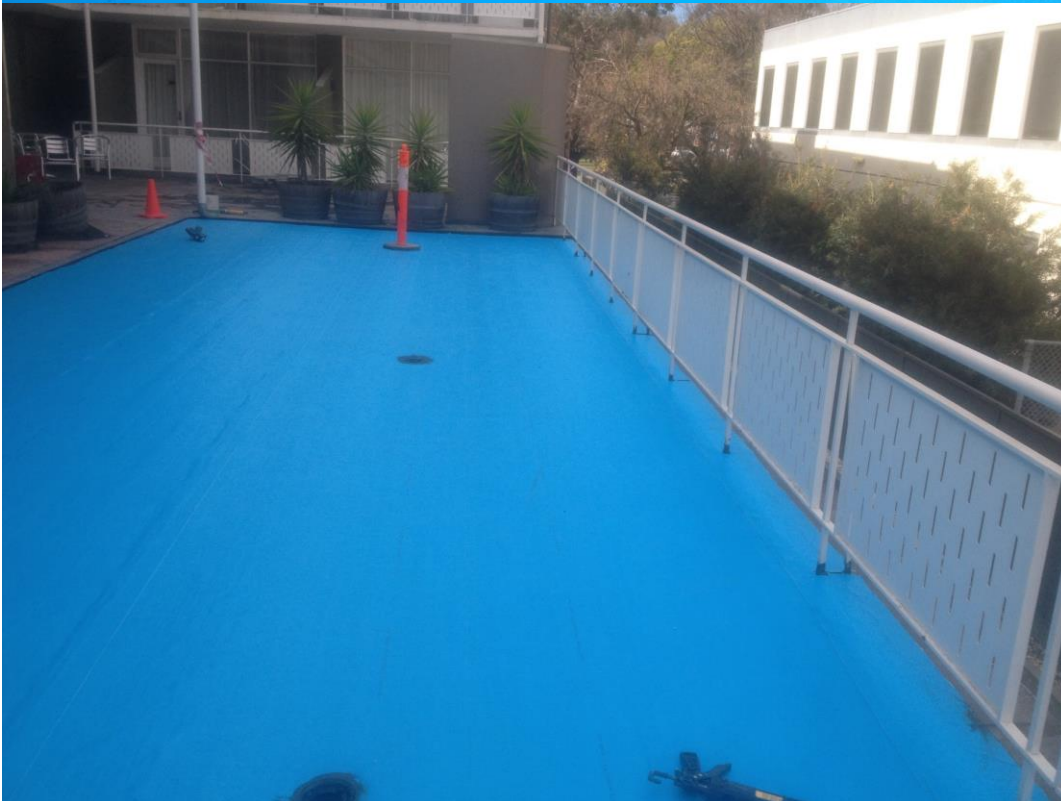
The finished waterproofing balcony had 4 coats applied.

After the waterproof membrane was completed, our premium protection sheet, Arma-Blue , was installed over the membrane.

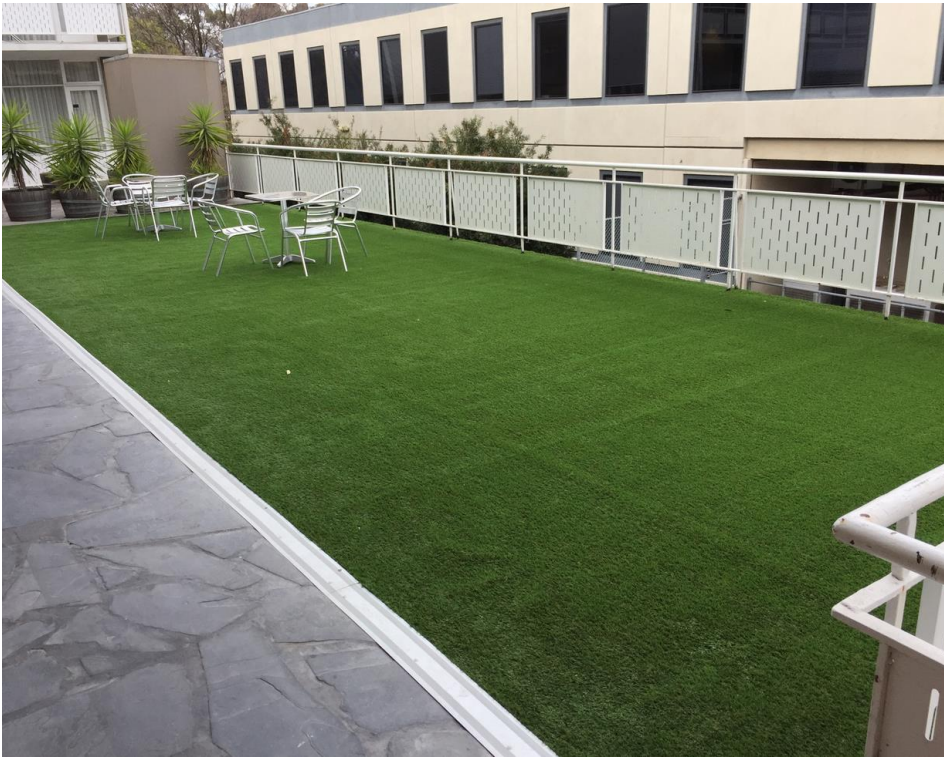
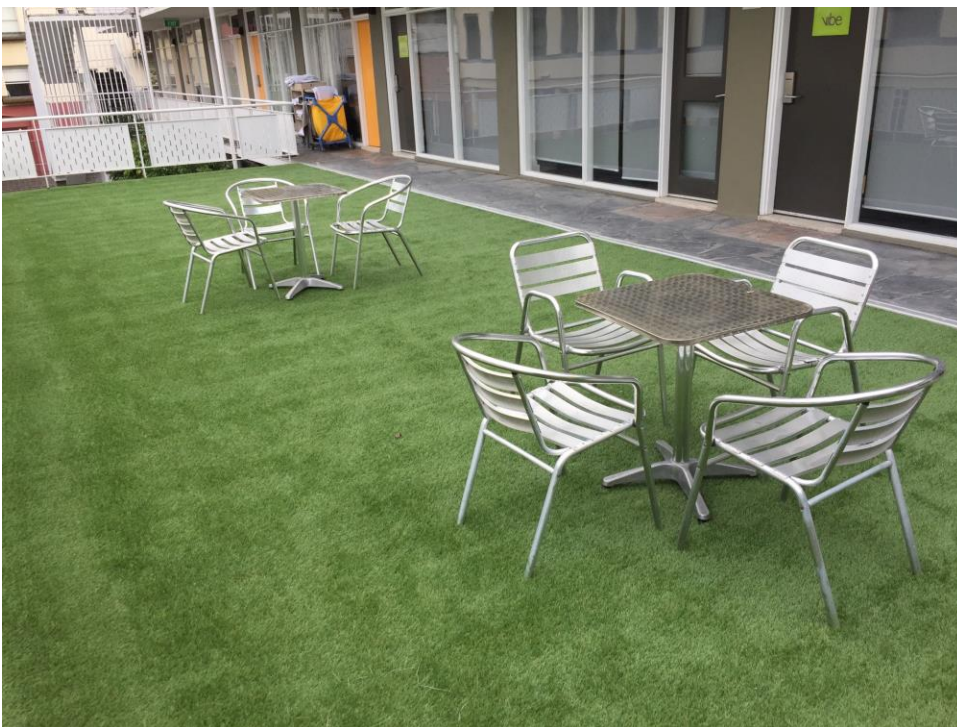
Instant Turf was then installed over the Arma-Blue.

This system the grass from the waterproof membrane.

So, when there is traffic & abrasion, the membrane is not affected.

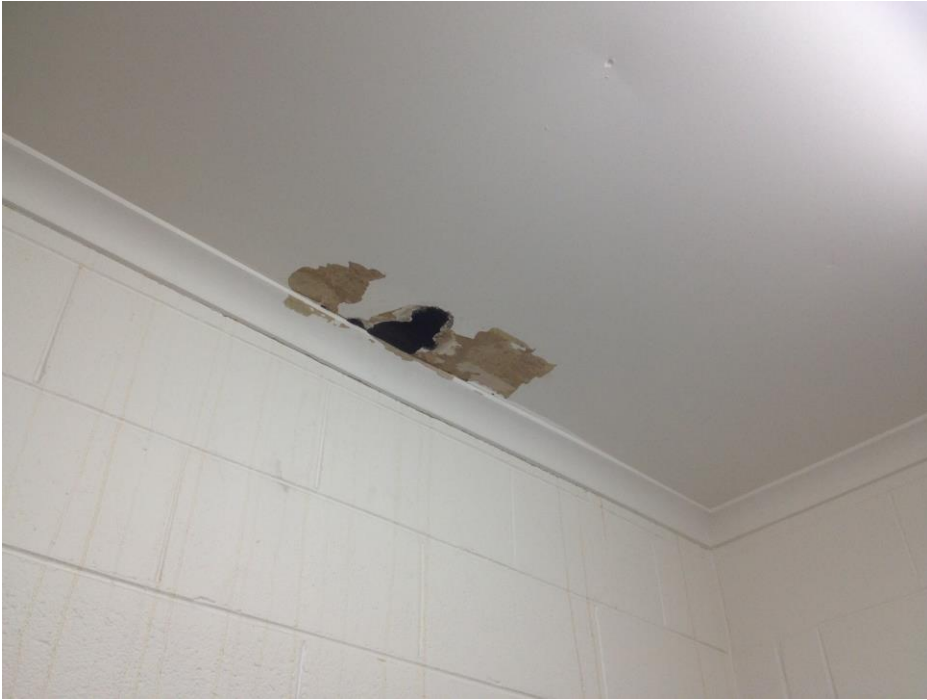
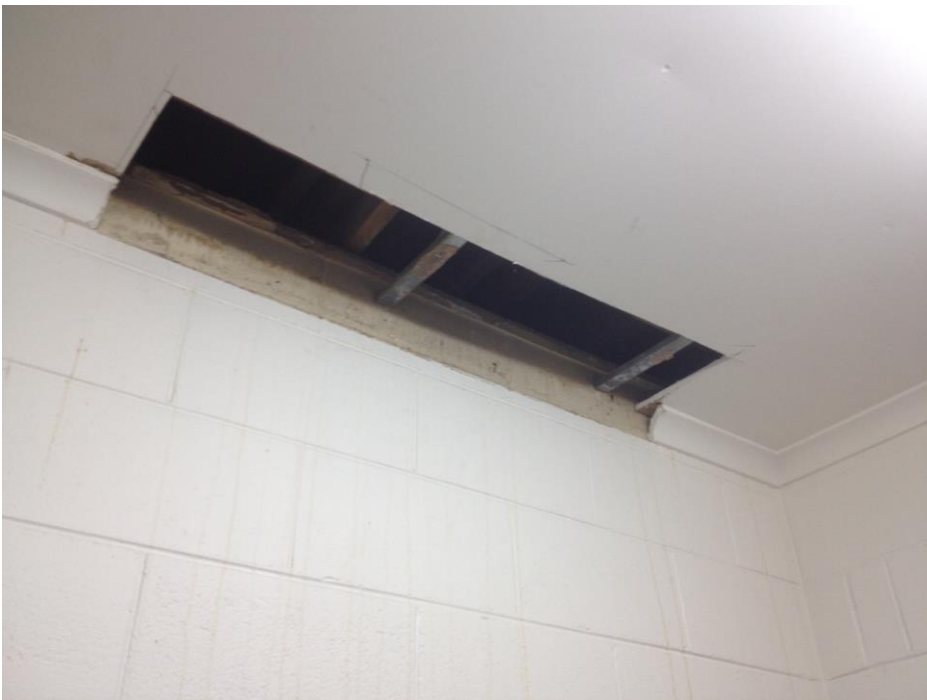
Internal repairs & construction was carried out. Ceilings, cornices & general plaster work completed, followed by painting. Kitchen facilities for the hotel were up & running very quickly.
